Rejuvenation of surface (Dug) well: One of the solutions to the Arsenic Problem

Buxar and Bhagalpur Districts
Bihar

SaciWATERs
July, 2020

Prepared for
UNICEF

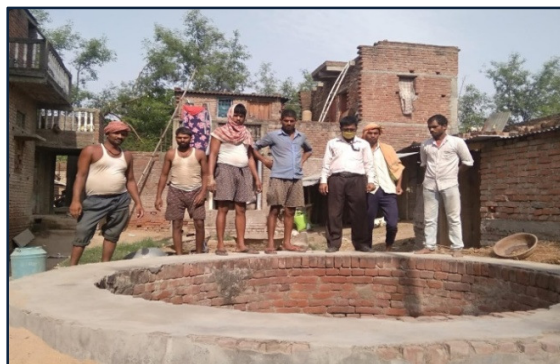
The well has been dysfunctional since 5 years. In the past, the water from this well was being used by approximately 15 families in the area for the purpose of drinking, washing, cooking, bathing and cattle feeding. The nearby temple also used the well water in past. The diameter of the well is approximately 7 feet.

Condition of the well before cleaning

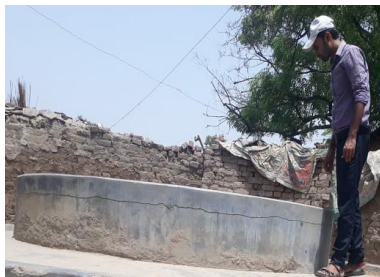
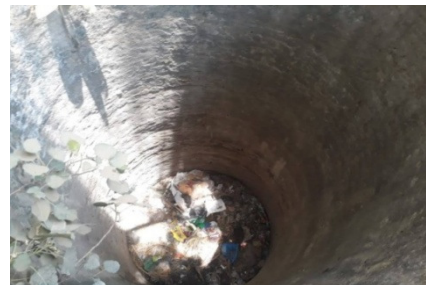
The well is in use but only when there is a shortage of water from other sources. Though, all families do not use water from this well. In the past, around 40 families were using water from this well for purpose of drinking, washing, cooking, bathing and cattle feeding. The diameter of the well is around 7ft.

condition of the well before cleaning

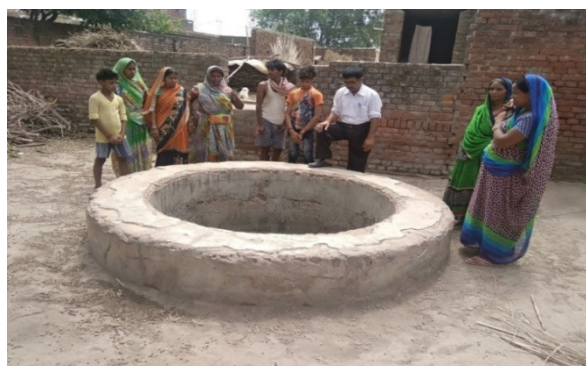
The well is not being used since very long time because the well water was contaminated with dust and garbage. The diameter of the well is approximately 11 feet. Currently the water is unusable and therefore not used at all.

condition of the well before cleaning

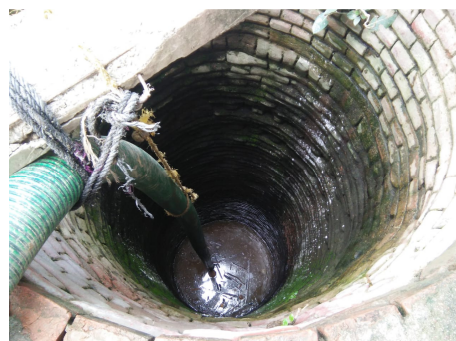
Arsenic contamination beyond permissible limit is reported in nearby tubewells and piped water supply sources. This was the foremost reason along with the location of the well to select this. The nearby habitation has approximately 200 households. The diameter of well is around 6.5 ft and 30 ft. deep. The well was not being used for drinking purposes but it was being used for other domestic purposes like cloth washing and vessel cleaning.

Condition of the well before cleaning

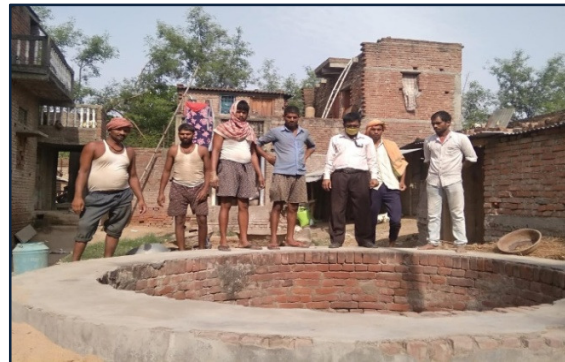
The preliminary assessment had been done to understand about the extent of cleaning and repairing. Accordingly, the material was arranged and labourers were hired.

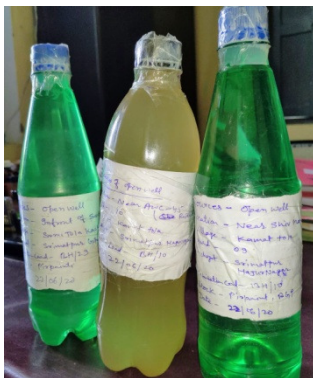
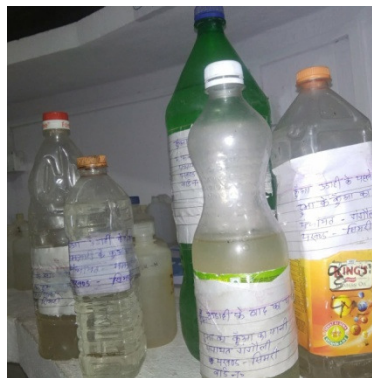
Samples of the all 6 wells have been taken and sent to the lab for testing.

Water samples sent for testing for all the six wells.

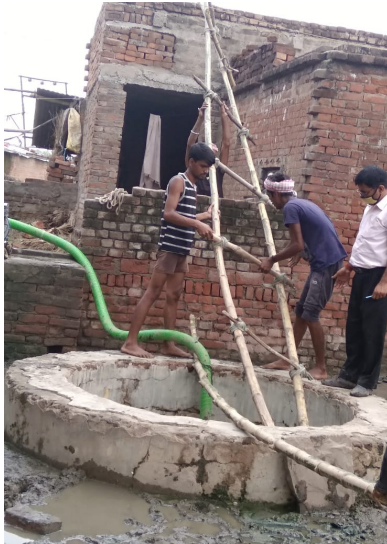
Using bamboo ladder to go into well

The dust, weeds, and algae from inside and around the surface of the wells were removed. Mud and waste material were removed using bucket. Outer and inner surfaces cleaned completely. Wet mud was removed from inside the well by digging upto 2 feet depth for recharge of water from the aquifer.

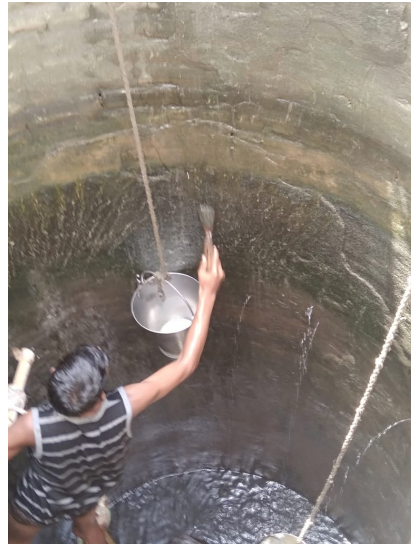
scratching green rigid algae from the inner wall

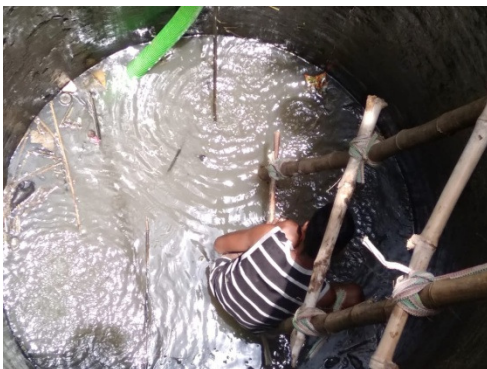
Laborers stated cleaning process

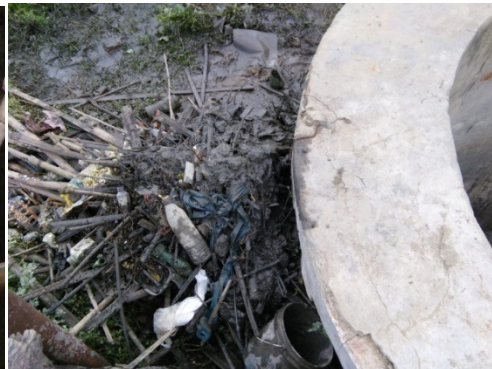
Waste material removed from well

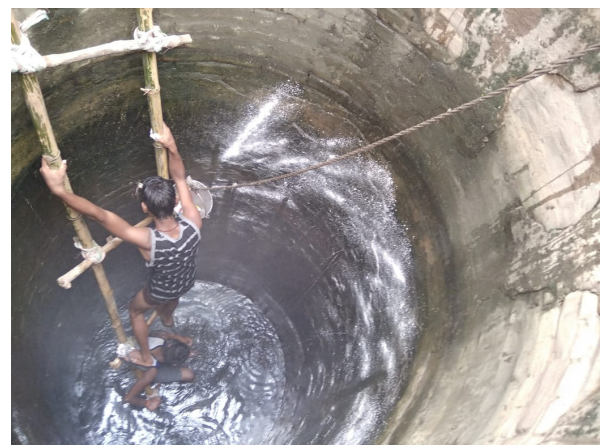
Application of bleach powder

After well cleaning and mud removal, bleaching powder will spread all around the wall surface of the well (inside and outside of the well) and has been kept unused for atleast 24 hours.

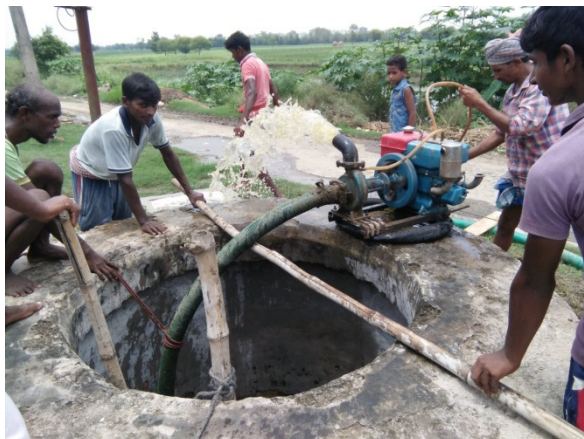
Dewatering of Well

The electric pump was used to remove the chlorinated water. The pumping has been done, until there is no smell of chlorination. Surrounding areas were also cleaned to ensure clean approach to the well.

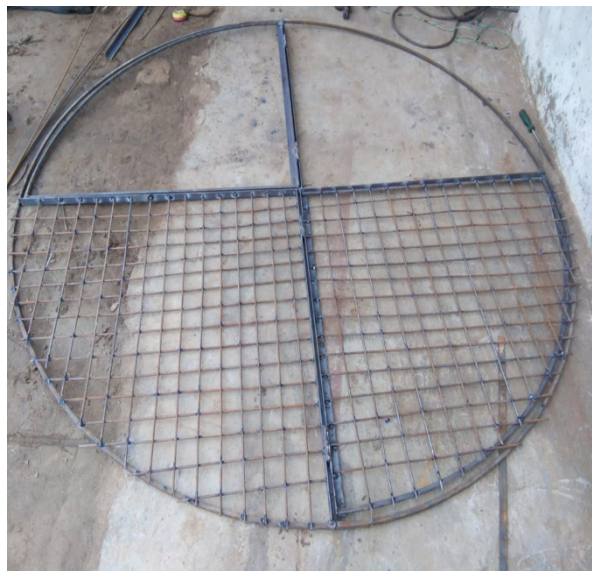
Iron Net to Protect and Cover the well

As per study, open well water source had arsenic free water as open wells found outside the home remains in contact with sun always in day time. However to overcome the problem of water contamination, due to dust and other garbage, use of covering with net on top of the well was made. This arrangement would help the sunrays to pass through and would also keep away from heavy dust and weeds to enter in the well from the nearby areas also.
