# Documenting Disappearing Water Bodies of Hyderabad City

# Documenting Disappearing Water bodies of Hyderabad City: Social Technological Options for Drinking Water Supply

Technical report

Prepared by SaciWATERs

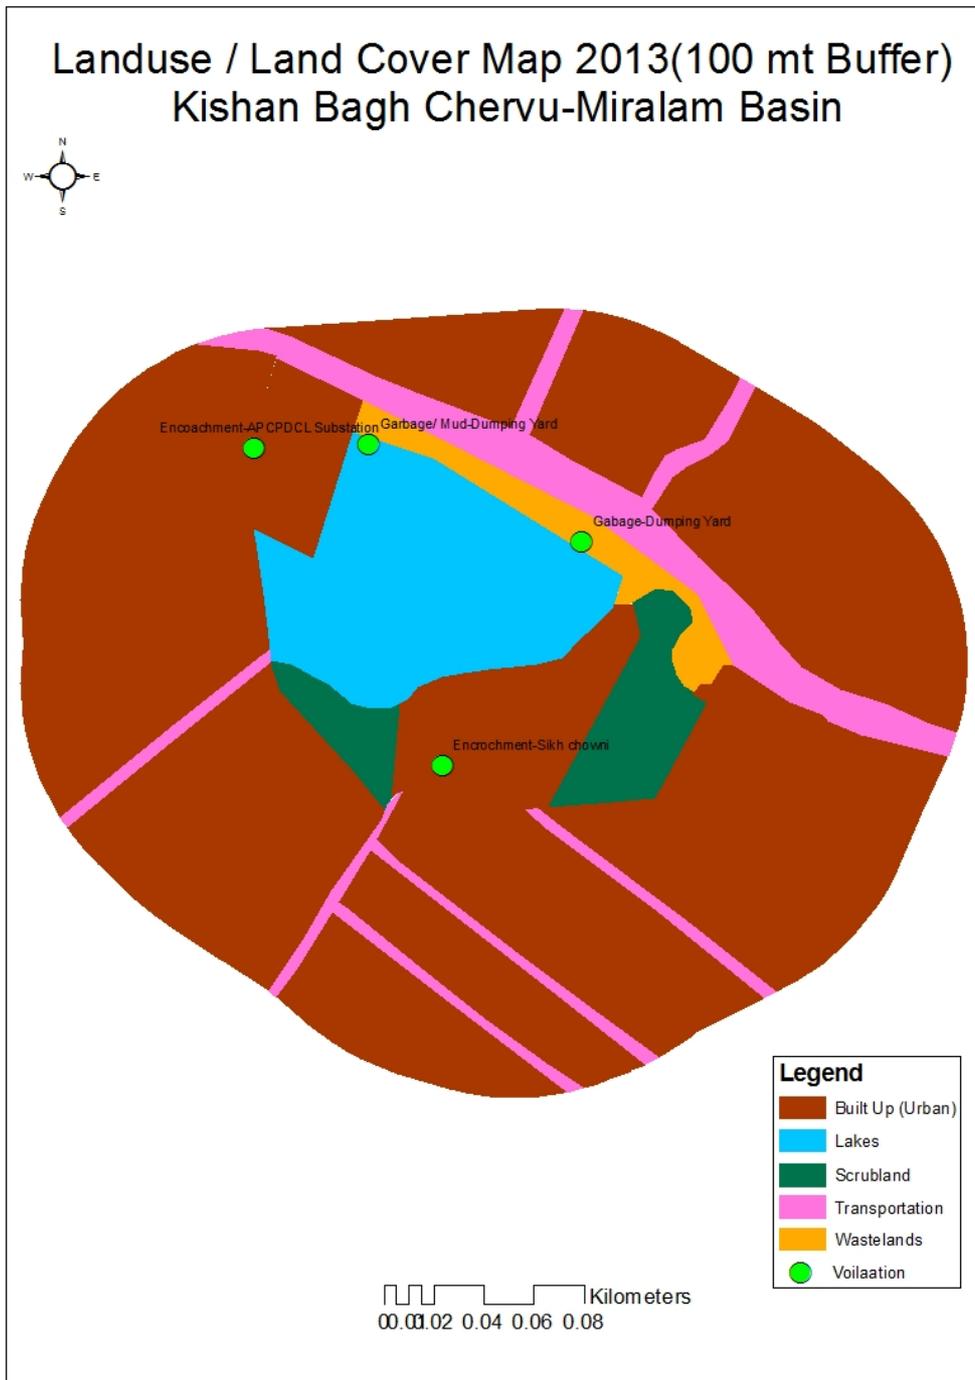
# Landuse / Land Cover Map 2013(100 mt Buffer)

Following section shows the tank wise land use and land cover change within Moir Alam meso-catchment. Within 100 meter buffer zone points of violations depicts the sad state of affairs that most of these lakes are going through.
